## CARMEL RIVER AT SCHULTE ROAD: Reconstruction of Steinbeck Era Channel Form

### CARMEL VALLEY, CALIFORNIA

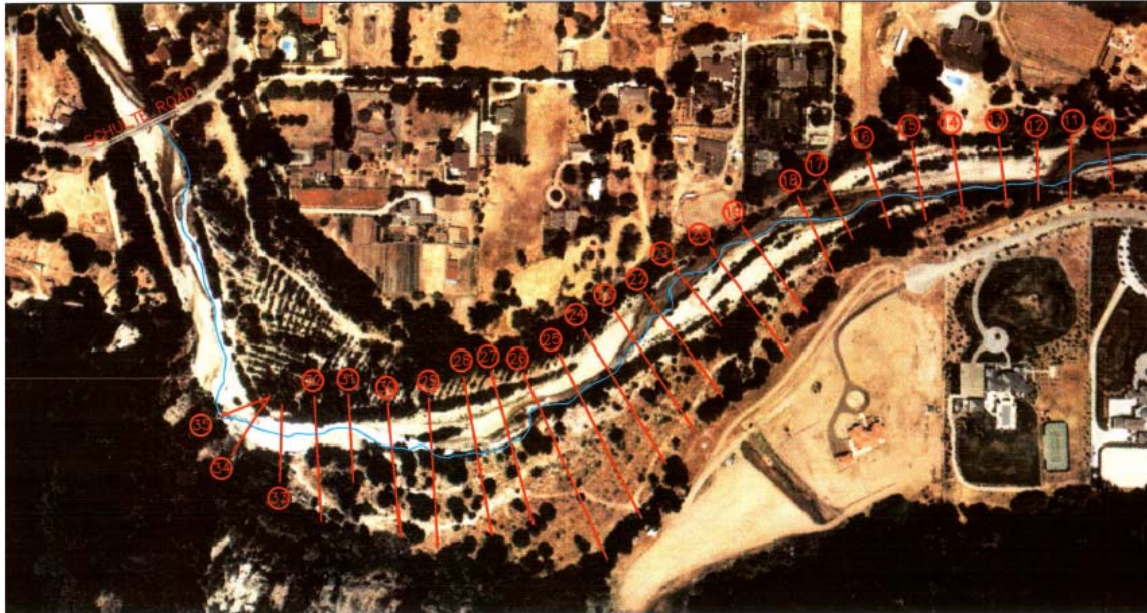
Image source: Graham Matthews (2000)

The bottomlands of Carmel Valley have been heavily urbanized in the last four decades and water table drawdown by municipal well pumps promoted increased bank erosion and channel instability. Near the Schulte road bridge, in a reach described by John Steinbeck in *Cannery Row* (1945), the river channel changed from approximately 24-m wide (80 ft), as had been the case in the 1940s-1970s (as), to being as much as 300-m wide (1,000 ft) in moderate floods in 1980-1983. The underlying cause was water table drawdown from groundwater pumping, which killed willows and cottonwoods, whose roots had stabilized the sandy banks. In an attempt to reverse the severe erosion, the Monterey Peninsula Water Management District (MPWMD) implemented the Schulte Road restoration project in 1988, consisting of channel realignment, construction of pool-riffle sequences and restoration of the riparian vegetation. Initially the riparian vegetation was irrigated, but for the last decade water tables have been maintained by shifting the locus of groundwater pumping downstream, to keep more of the river flowing perennially. Today a dense and diverse riparian woodland is established on the floodplain, which is now inundated during floods every few years, sustaining a diverse riparian flora. The low-flow channel has adjusted but remained essentially stable, a necessary condition given the urban uses adjacent to the river channel.

This is a model project because bioengineering techniques were used to stabilize eroding riverbanks resulting from bank devegetation resulting from water table drawdown from groundwater pumping for municipal use. The reconstructed channel was allowed to migrate within a narrowly delineated floodplain, based on historical channel configurations observed on historical photographs.
